MEMORANDUM

TO	Lynn Sullivan, Project Manager	DATE	November 27, 2006
	Seattle Parks and Recreation	PROJECT No	200607
	800 Maynard Avenue South, 3 rd Floor	PROJECT	(WC2281)
	Seattle, Washington 98134		Lake Washington Boulevard
CC			South Drainage Improvements
SUBJECT	Drainage Assessment and Conceptual Design	FROM	Mike DeLilla, P.E.
T		PAGE	1 OF 10

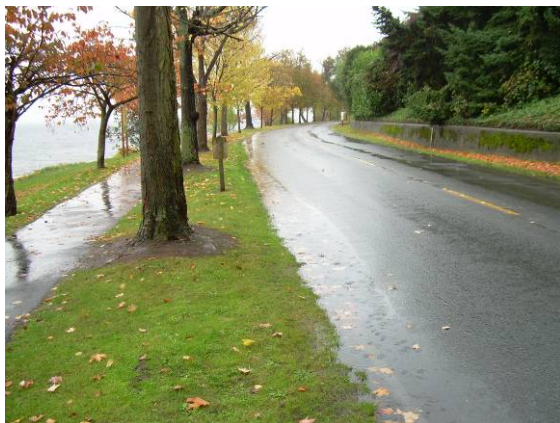
Site A is located in the vicinity of the entrance to the Mount Baker Bathing and Boating Park. Drainage problems occur in the driveway and along both sides of Lake Washington Boulevard South. See Figure A-1. There are twelve existing pot drain systems located in the lawn areas and spaced approximately 70-feet apart along the roadway. Each system consists of one pot drain on each side of the road and is connected to each other by pipe. It is unknown if the pipes connecting the pot drains are damaged. The size of the pot drains are 6-inches in diameter and are covered by leaves and debris. The lawn around the drains is overgrown and obstructs the runoff which causes standing water in the roadway and saturates the lawn areas. The outfall to each system appears to be located along the grass bank into Lake Washington. Most outfalls could not be identified during the site visit and appear buried.

Figure A-1
Looking south on Lake Washington Boulevard South from the driveway entrance

The existing pot drains are outdated and assumed no longer functioning. SPRD would like to replace or install additional pot drain systems to improve the drainage in this area. The replacement of culvert pipe crossing Lake Washington Boulevard South and the outfall pipe are also estimated. These small systems are susceptible to clogging and scheduled maintenance will be needed to keep these drains functioning during the wet season. Areas around all the pot drains should be cleared to prevent future problems with overgrowth. See Figure A-3. Other grate options such as trash racks may be used for additional protection against leaves and debris. Larger structures such as City of Seattle Type 252 inlets provide a greater collection area and less maintenance.

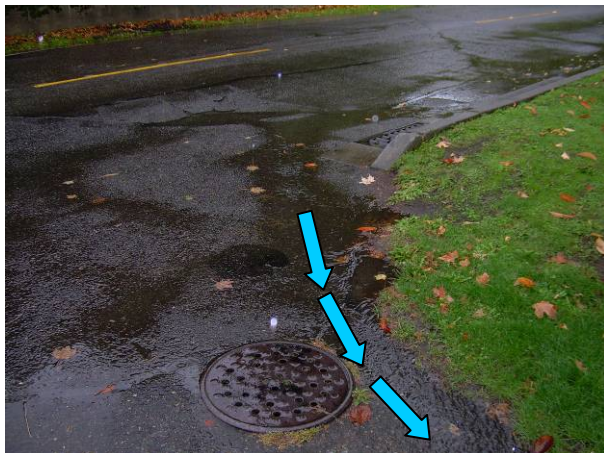
On the north side of the entrance, storm drainage from the roadway sheet flows down the driveway where it crosses the sidewalk and continues into the parking lot. See Figure A-2. The concentration of flow from the roadway may create a hazard to pedestrians using the sidewalk. Replacing the existing storm drain manhole with a circular grate and diverting flow into this structure will reduce the amount of flow coming into the parking lot. Diverting flow may be done by either lowering the structure or adding an asphalt edge/berm.

Figure A-2
Storm water sheet flows down the driveway to the boat park

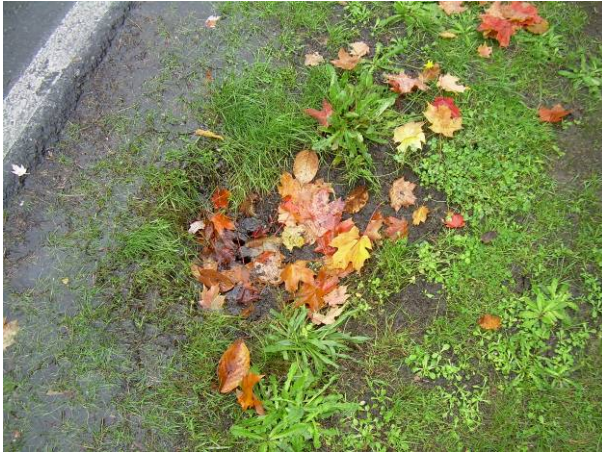
Figure A-3
Existing pot drain clogged with leaves and no flow path into the structure

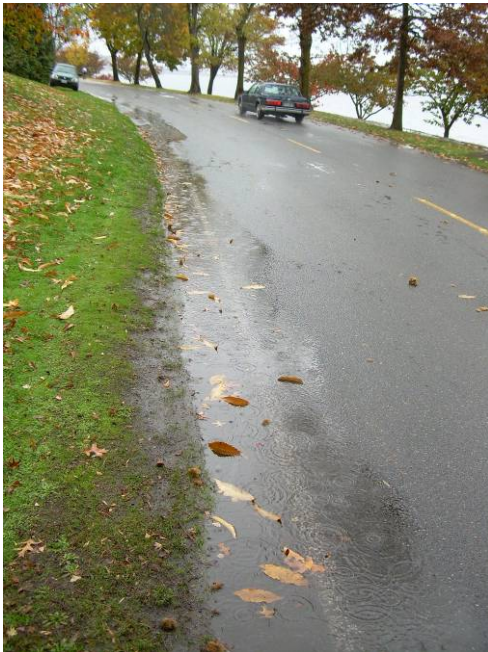
Site B is located on the west side of Lake Washington Boulevard South in the vicinity of Horton Place loop. The drainage problems occur along the west edge of the roadway. See Figure B-1. Drainage for the west half of the road flows north along the roadway shoulder. There is one existing pot drain within the lawn and the flow path to this drain is obstructed by the growth of the lawn. Since the lawn area is higher than the roadway the storm water is trapped and begins to encroach into the traveled way. Temporary clearing of a path to the pot drain shows the storm water slowly retreating from the roadway. Further inspection uncovered that the drain structure is missing allowing debris to fill the void and pipe culvert underneath Lake Washington Boulevard South. See Figure B-2

Figure B-1
Looking north on Lake Washington Boulevard South

Cutting back the lawn and lowering the grade will move the storm water off the roadway. A larger structure such as City of Seattle Type 252 inlet will provide a greater collection area and less maintenance. Providing an unobstructed flow path into the replaced structure will alleviate the existing encountered problems. If this structure is replaced and maintained, this area will drain more effectively. The condition of the culvert pipe crossing Lake Washington Boulevard South is unknown. The replacement of this pipe will be similar to Site A costs.

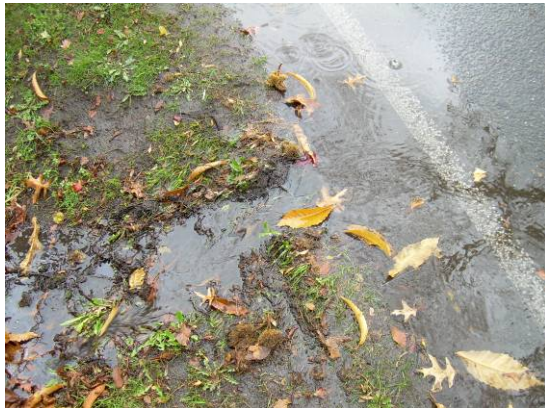
Figure B-2
Temporary clearing to pot drain

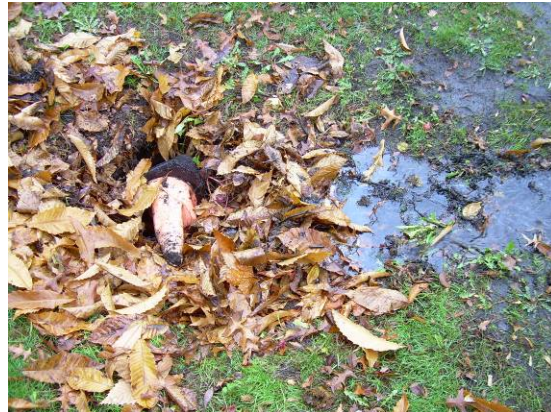
Figure B-3
Location of missing pot drain

- Remove and replace existing pot drain system. Install Type 252 inlet on west side.
- Minor grading and lawn maintenance

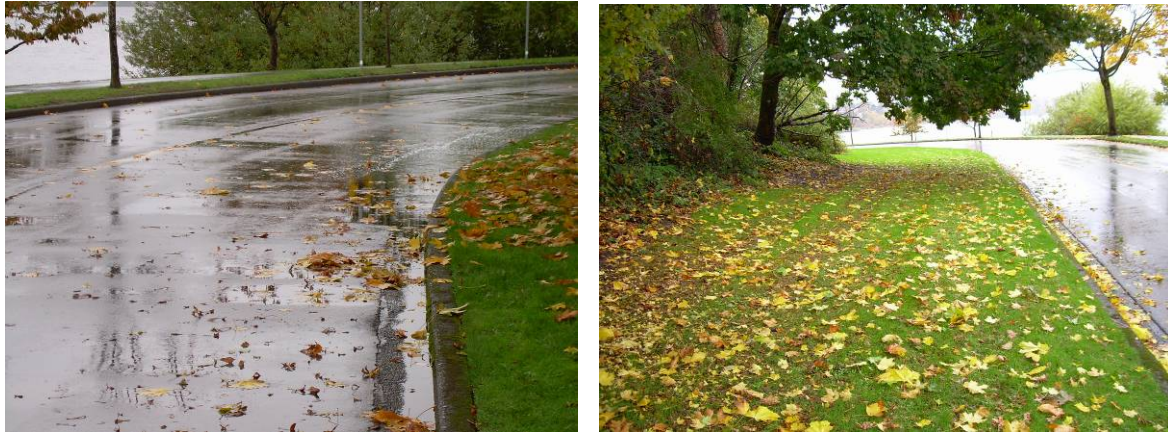
Figure C-1

Site C is located on the west side of Lake Washington Boulevard South between 50th Avenue South and 51st Avenue South. The drainage problems occur along the west curb line and within the lawn adjacent to the roadway. See Figure C-1. An existing inlet near the south west corner of the intersection with 50th Avenue South collects roadway runoff between the two streets along with storm water from 51st Avenue South. The flat roadway and long path to the inlet causes standing water along the curb line during heavy rain events. However, it appears that that storm water is flowing into the structure at a very slow rate. The lawn area is flat and in some places depressed. Storm water collects and absorbs slowly into the subsurface creating soggy conditions. Currently, there is no drainage system for the lawn area. Runoff from the hillside may also add to the lawn area being oversaturated.

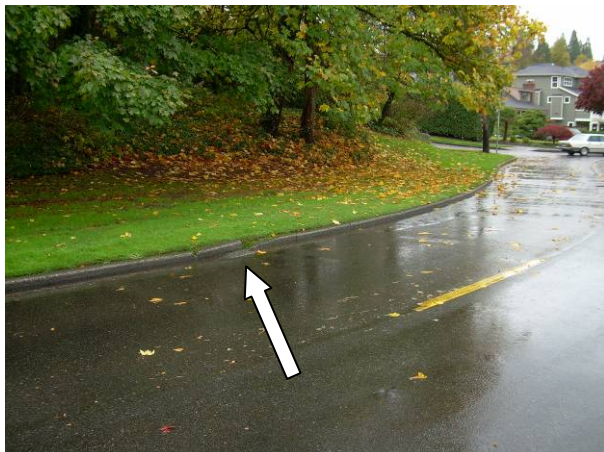
Figure C-2

Storm water appears to pond in this area because of the flat grade along the curb line. Storm flow loses momentum around the roadway curve and is impeded by a portion of the curb that needs adjustment. See Figure C-2. It appears that the curb in this location is raised so that it moves flow out of the curb line. From this point, planing of the existing roadway along the curb line will increase the fall towards the north. The existing inlet is shallow and connects approximately 10-foot north to a storm drain manhole at the south west corner of 50th Avenue South. Removing the inlet to allow storm water to flow directly into this manhole will provide sufficient depth to lower the structure and increase the grade. Roadway surveying is required to determine how much the storm drain manhole could be lowered to maximize the grade. The storm drain manhole will need to be replaced with a circular grate.

An alternative option is to install an additional catch basin in the area of the ponding. The new structure will outfall directly to the east into the grass banks of Lake Washington via culvert pipe underneath the roadway. Outfall protection will need to be placed to prevent erosion. The curb mentioned previously will also be fixed in this option. Further investigation involving other utilities in the roadway will need to be determined to discuss the feasibility of adding a structure and culvert.

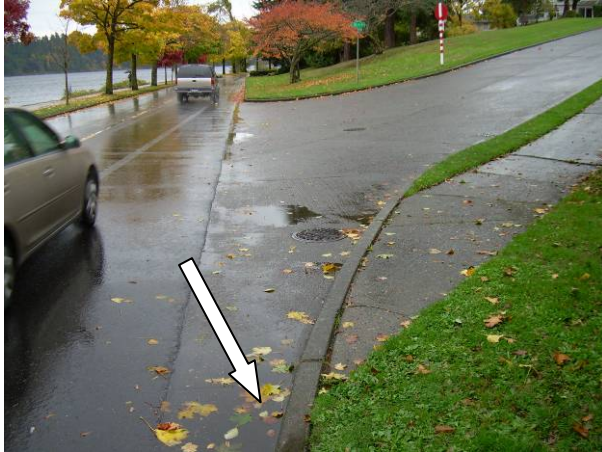
Figure C-3
Proposed location for added inlet to collect runoff from the south

The amount of surface runoff may be reduced by adding an inlet structure to the northwest corner of the intersection of 51st Avenue South. See Figure C-3. Adding this structure will reduce the runoff coming from 51st Avenue South and Lake Washington Boulevard South. The new structure will connect to the existing storm drain manhole (Figure C-3) to minimize roadway impacts.

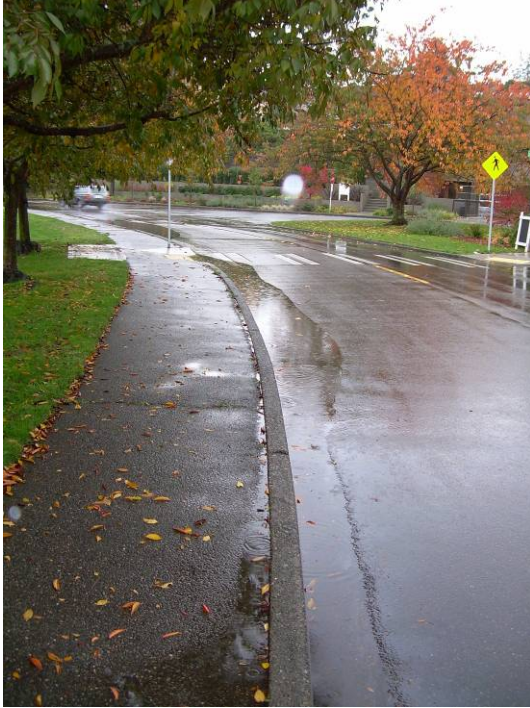
Site D is located at the intersection of S. Orcas Street and Lake Washington Boulevard South. The drainage problems occur along the east curb line stretching between and beyond the two “new” ADA ramps. See Figure D-1 and D-2. There are existing curb drains throughout this area, but settlement in the flat roadway prevents storm runoff to be conveyed to these drains. The drains are currently clogged causing storm water to pond and encroach into the traveled roadway. If these drains were maintained it would only alleviate some of the drainage problems in this area. Additional roadway and drainage improvements will need to be made in this location.

Figure D-1
North ADA ramp

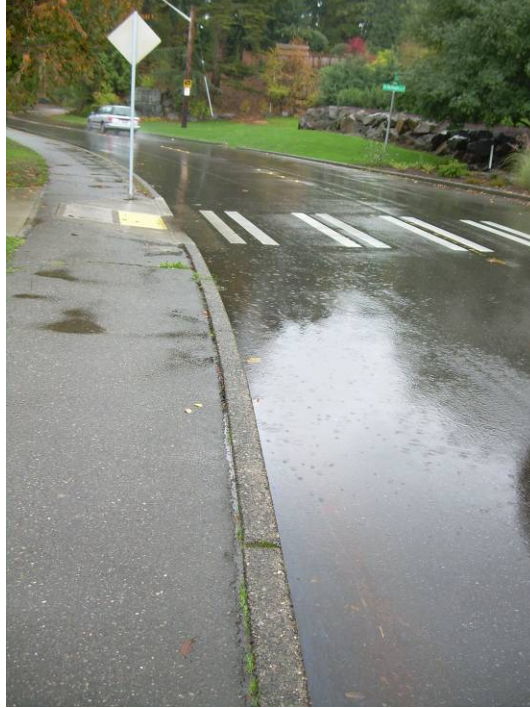
Figure D-2
South ADA ramp

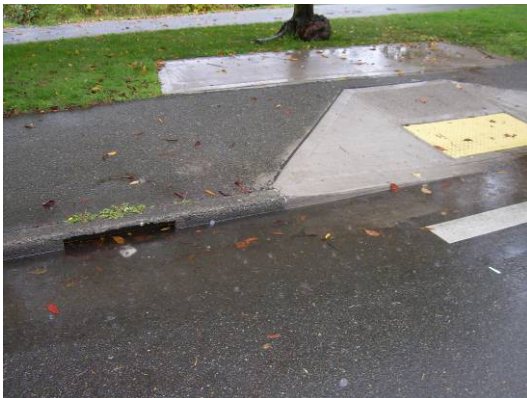
Figure D-3
Clogged drain near the north ADA ramp

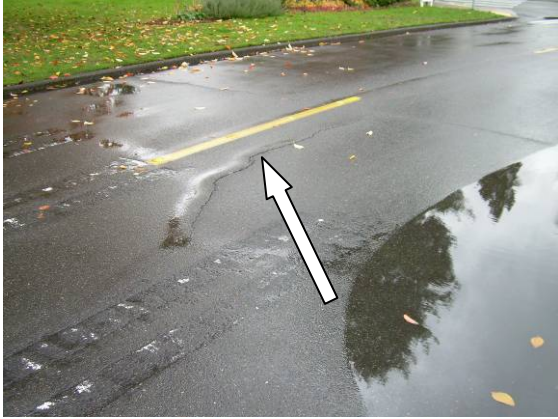
Settlement in the roadway is the biggest cause for the drainage problems in this area. The cause of the settlement is unknown and is likely this section of the roadway will eventually need to be repaired. See Figure D-4 and D-5. Resurfacing the roadway to eliminate the undulations will improve flow to the existing drains in these areas. Planing the ridges in the pavement will reduce the standing water to flow into the existing drains. See Figure D-5. Installing additional curb penetrations in low spots that outfall east into Lake Washington will improve this area; however,

Figure D-4
Roadway settlement in the northbound lane

- Install curb penetrations near ADA ramps and low points
- Repair roadway, and planing pavement ridges

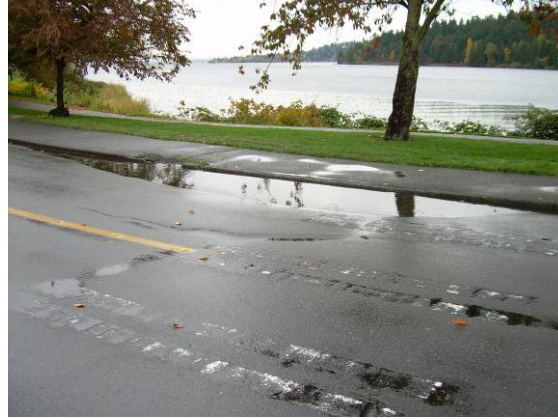
Figure D-5
Ponding caused by the settlement in the roadway

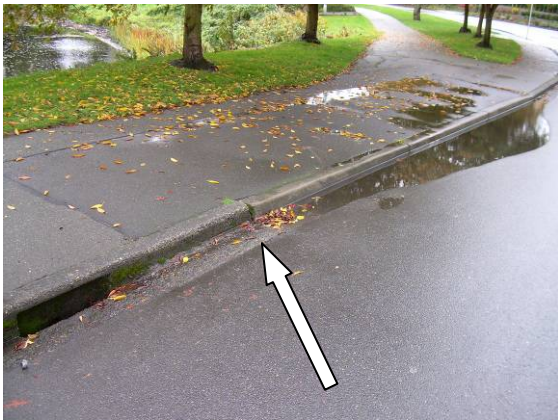
Figure D-6
Undulations in the roadway preventing runoff to drain

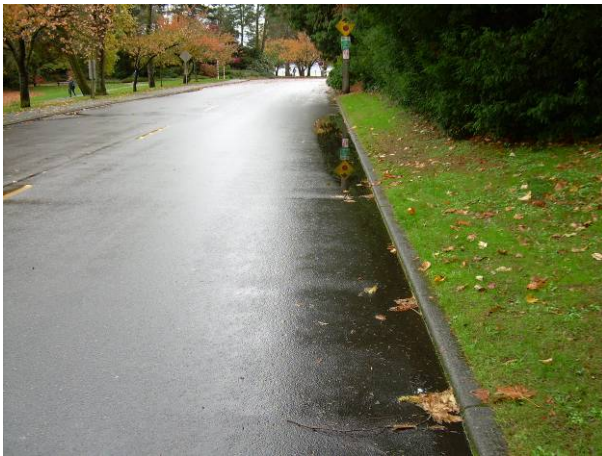
Figure E-1

Site E is located on the west side of Lake Washington Boulevard South approximately north of the entrance to Seward park where ponding occurs along the curb line and encroaches into the roadway. There is one existing catch basin to drain this area, but due to the flat and undulating roadway, the storm water is not conveyed to this drain. See Figure E-1.

Resurfacing the roadway in this area to remove the undulations will create grade to the existing drain. The west half of the roadway will need to be removed by planing the existing asphalt overlay. At the low point, the new pavement could be placed as high as the top of the curb. This will provide sufficient grade along the curb to the existing drain. Further field investigation and roadway surveying will be needed to finalize the design.

An additional option is to install a catch basin in the area of the low point, and connect to the existing catch basin to the north.
