MEMORANDUM

TO	Lynn Sullivan, Project Manager	DATE	November 27, 2006
	Seattle Parks and Recreation	PROJECT No	200607
	800 Maynard Avenue South, 3 rd Floor	PROJECT	(WC2281)
	Seattle, Washington 98134		Lake Washington Boulevard
CC			South Drainage Improvements
SUBJECT	Drainage Assessment and Conceptual Design	FROM	Mike DeLilla, P.E.
T		PAGE	1 OF 10

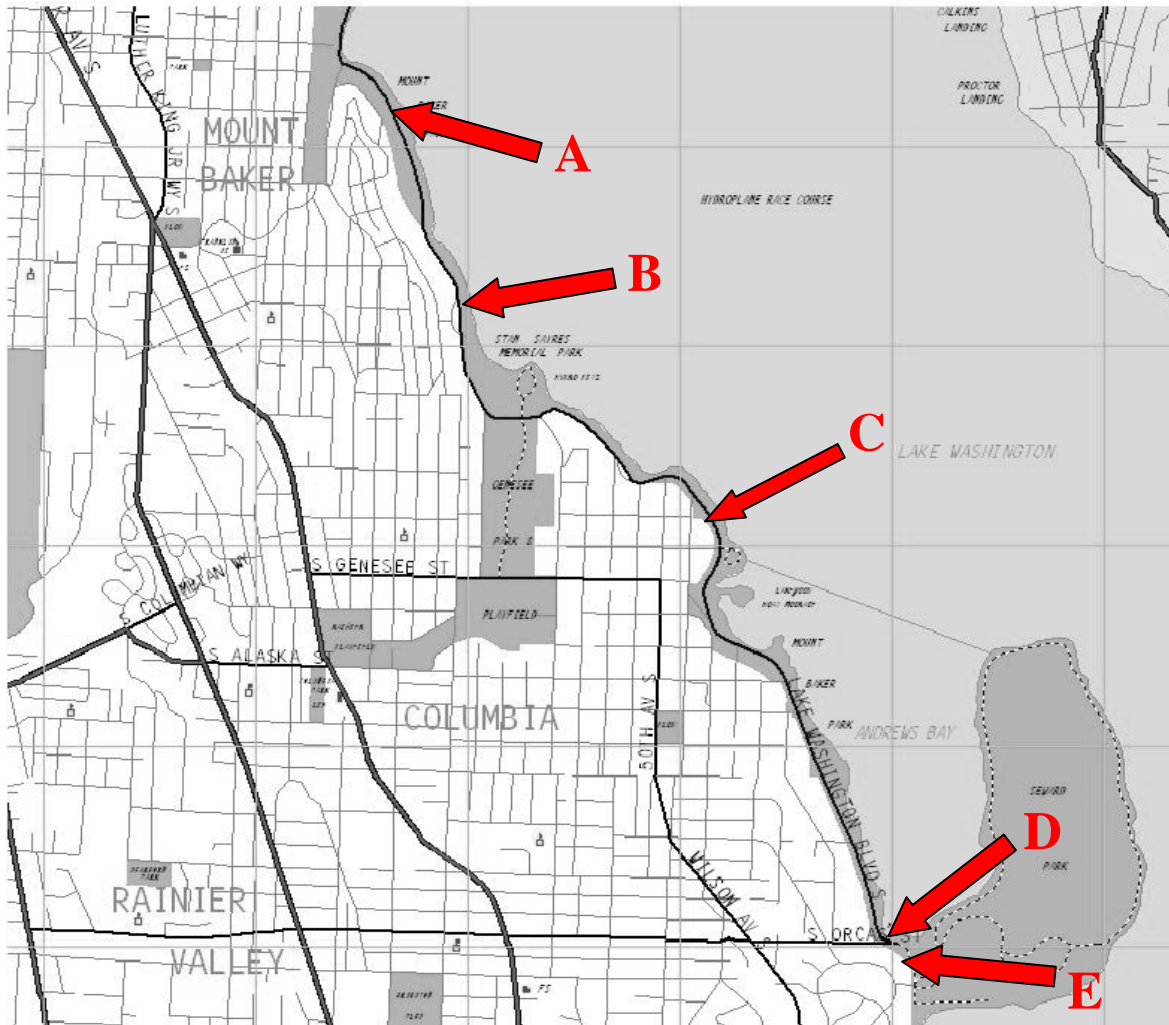
Exhibit 1
Lake Washington Boulevard South Drainage
Site Locations

Site	Seattle Parks & Recreation Site Descriptions
A	Approximately 70-feet of the west shoulder of Lake Washington Blvd near the entrance of the Mount Baker Bathing and Boating Park;
B	Lawn area/west shoulder of Lake Washington Blvd at Horton loop;
C	West side of Lake Washington Blvd between 50 th and 51 st Ave S.;
D	Three (3) new ADA ramps located near the intersection of South Orcas St. and Lake Washington Blvd;
E	And the catch basin located on the west side of Lake Washington Blvd south of South Orcas St. and North of Lake Washington Blvd.
